Technical report – September 2023

Safety analysis of large-area hall roofs in the event of unintentional loading due to heavy rainfall.

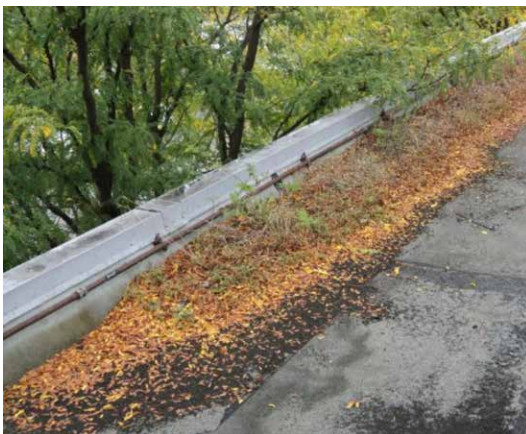
Photo 2. Debris accumulation on the roof edge affecting the effectiveness of the roof surface drainage system [16-S2].

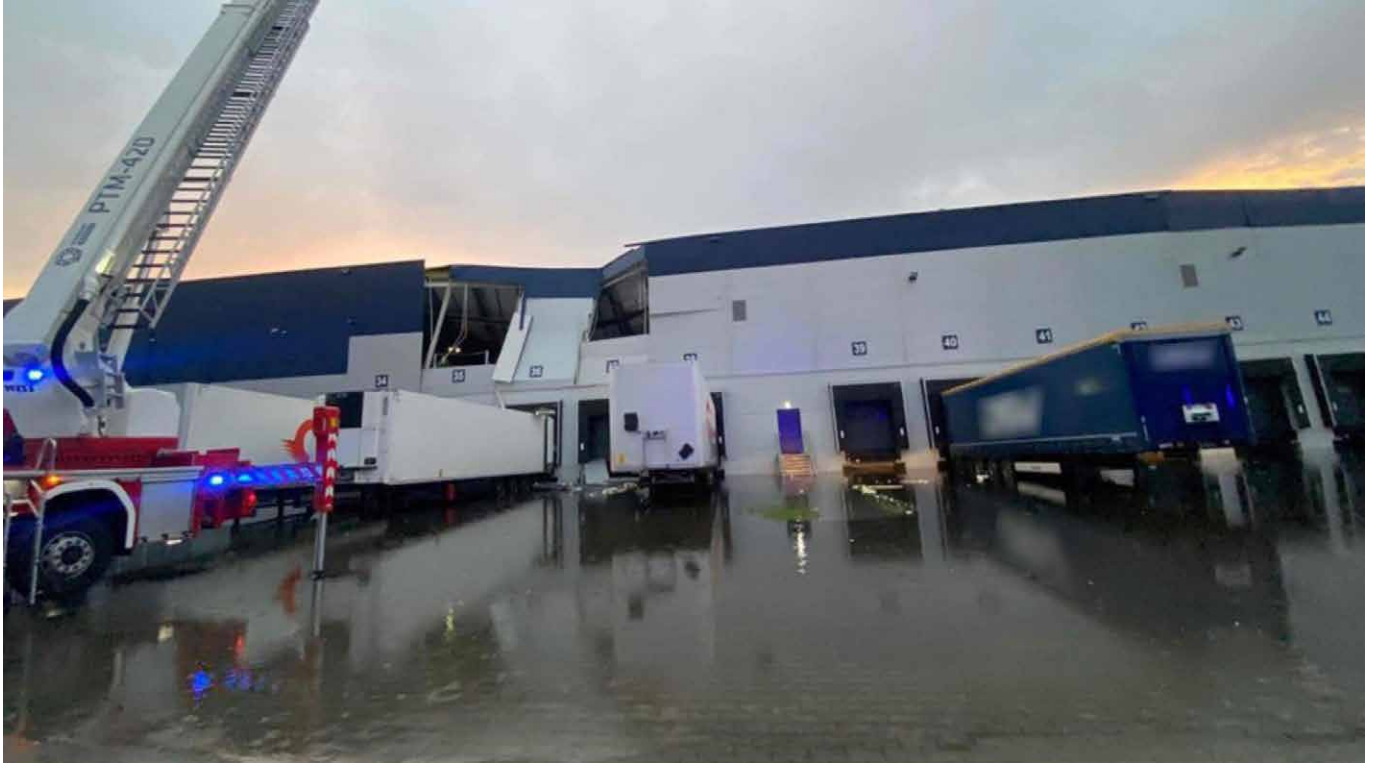
Photo 1. Szczecin. Collapsed roof of the hall at Kablowa Street [S1].

The basis for this technical report is a number of media reports on the collapse of part of the roof of a large-area hall, which occurred on 18 August 2023 in Szczecin at Kablowa Street (Photo 1).

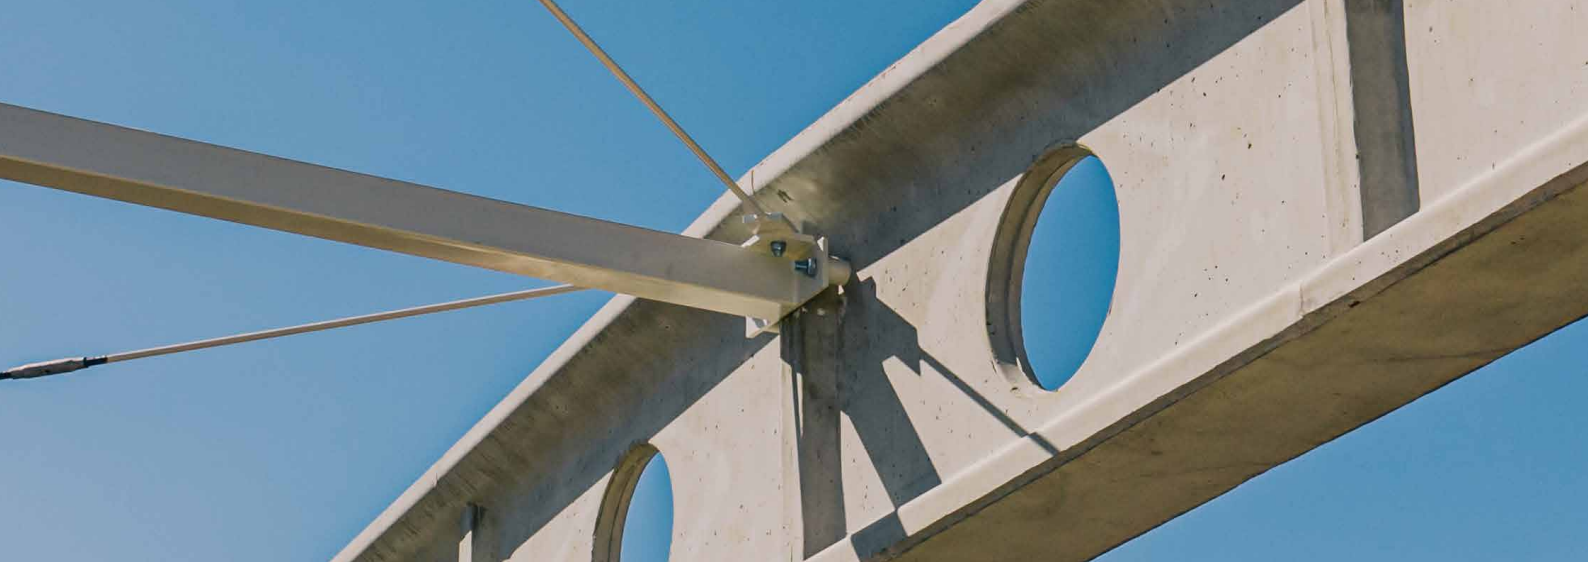
This section focuses only on the design reserve generated by the design coefficient for the self-weight of the roof girders. EN 1990 [N5] imposes a design coefficient of 1.35 on the permanent loads of the structure. Such loads include the self-weight of the structure – the self-weight of the roof girders. The steel truss selected in accordance with the above description has a mass of approx. 1,580 kg.

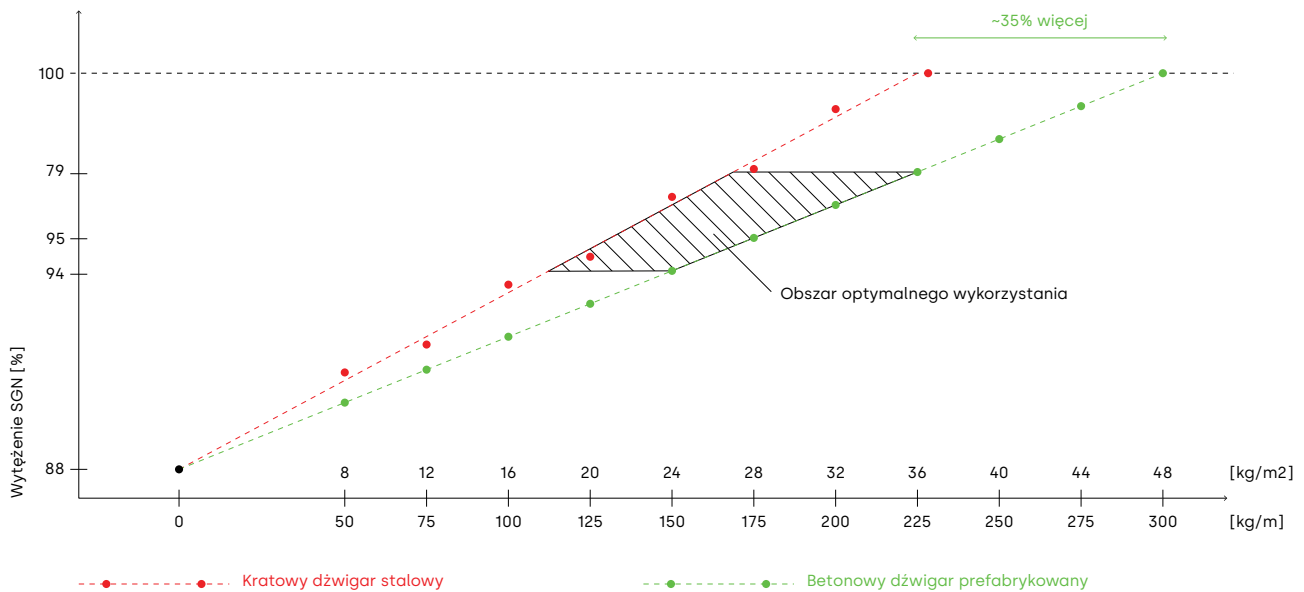
Fig. 3. Utilisation of the roof girder load capacity as the additional external load increases (additional kilograms per metre of girder length [kg/m], additional kilograms per m² of roof [kg/m²]).

The next step of the analysis carried out is to demonstrate the 'inertia' of the roof girders analysed. To this end, the elements were analysed and selected for the same set of external loads so that their effort due to bending at the Ultimate Limit State (ULS) was equal and amounted to approximately 88%. Then, the loads were increased in increments of 25 kg/m of girder length. The results are shown in the diagram below (Fig. 3).

The data shown in the diagram above illustrates the clearly greater inertia of a roof made using prestressed concrete girders as structural elements. With an increase by the same value of the effort in the SGN, about 35% more load can be added to a prestressed concrete girder than is the case with a steel truss. An increase in the external load by the same value causes a significantly faster increase in the effort of the steel truss than that of the pre-stressed concrete girder.

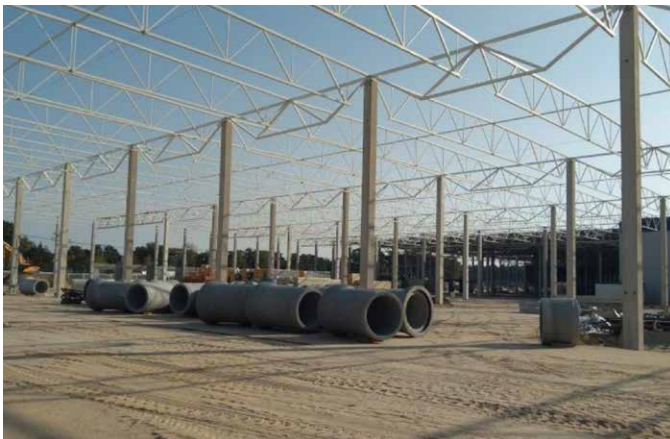
Photo 3. Roof of the hall made using steel prefabrication technology [S5].

A view of the construction of a large-area hall using steel trusses is shown in Photo 3, while a hall using pre-stressed concrete girders is shown in Photo 4. The subjective perception of roof stability in the case of the two types of girders used is quite different.

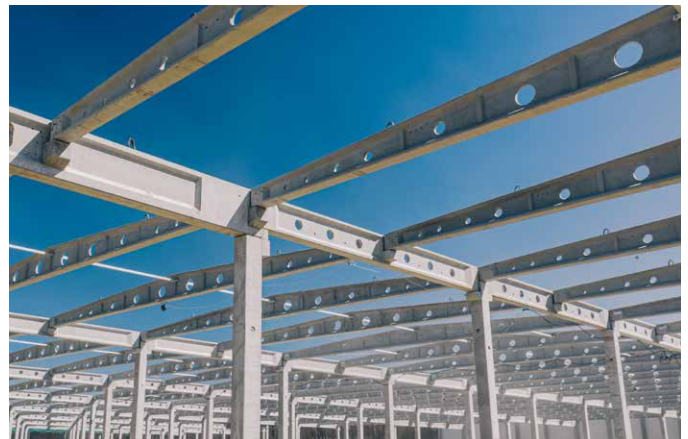
Photo 4. Roof of the hall made in prefabricated prestressed concrete technology [PEKABEX].
